DEPARTMENT OF TRANSPORTATION**DIVISION OF ENGINEERING SERVICES**

Contract #: 04-0120F4Cty: SF/ALA Rte: 80 PM: 13.2/13.9File #: 69.28**WELDING INSPECTION REPORT****Resident Engineer:** Pursell, Gary**Address:** 333 Burma Road**City:** Oakland, CA 94607**Report No:** WIR-009678**Date Inspected:** 02-Oct-2009**Project Name:** SAS Superstructure**OSM Arrival Time:** 700**Prime Contractor:** American Bridge/Fluor Enterprises, a JV**OSM Departure Time:** 1900**Contractor:** Zhenhua Port Machinery Company, Ltd (ZPMC), Changxing Island **Location:** Shanghai, China**CWI Name:** ZPMC and ABF**CWI Present:** Yes No**Inspected CWI report:** Yes No N/A**Rod Oven in Use:** Yes No N/A**Electrode to specification:** Yes No N/A**Weld Procedures Followed:** Yes No N/A**Qualified Welders:** Yes No N/A**Verified Joint Fit-up:** Yes No N/A**Approved Drawings:** Yes No N/A**Approved WPS:** Yes No N/A**Delayed / Cancelled:** Yes No N/A**Bridge No:** 34-0006**Component:** OBG**Summary of Items Observed:**

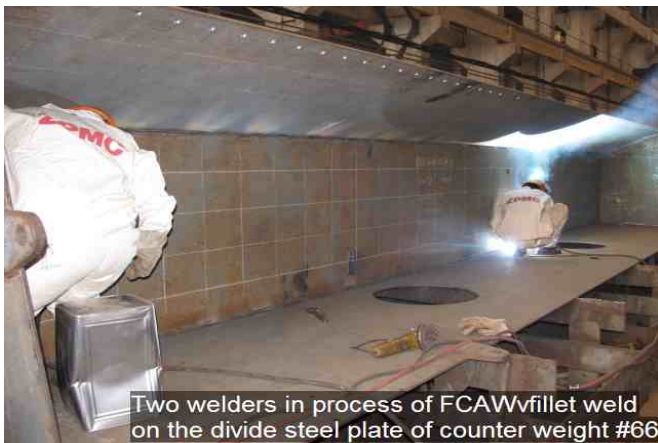
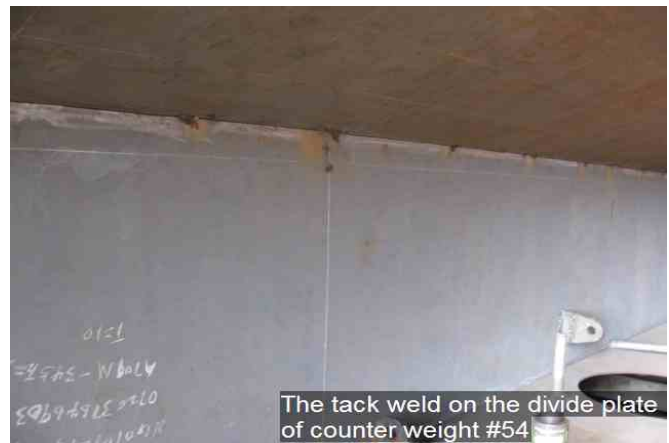
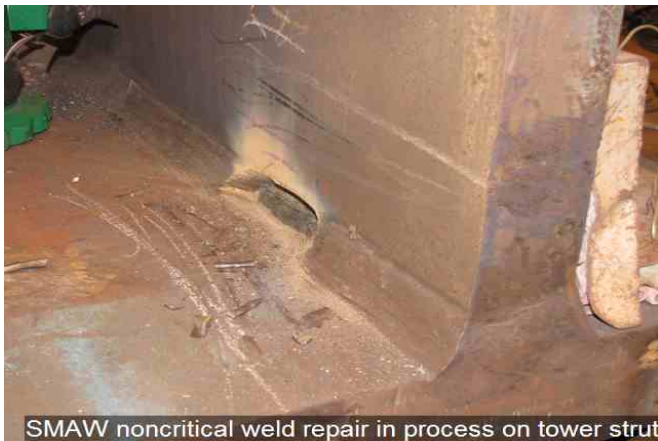
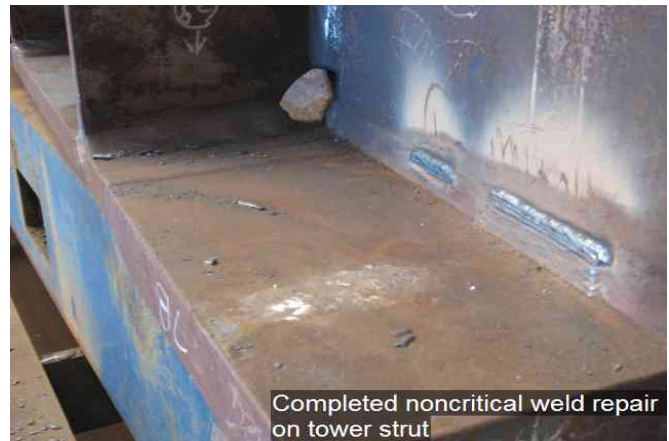
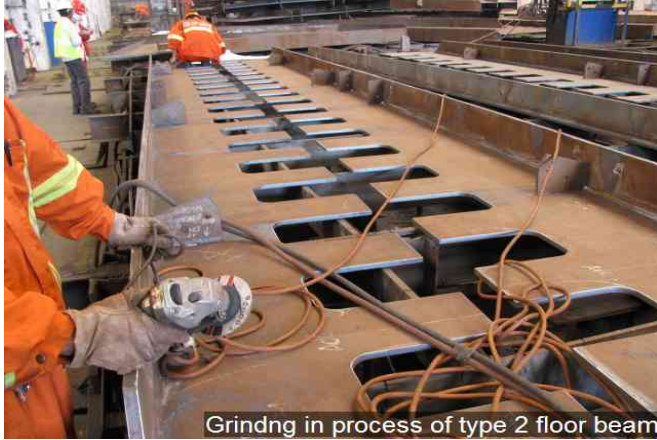
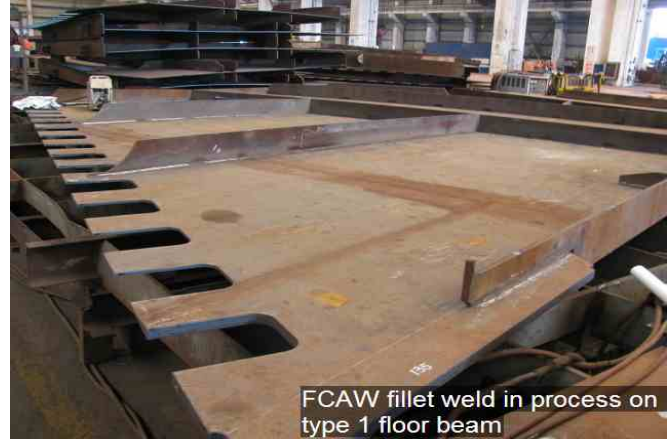
Counter weight: - Caltrans QA inspector observed two ZPMC welders performed FCAW fillet weld process on divide plate of counter weight component #66. The fillet weld size is 8mm welded all around the plate with multiple pass. The FCAW fillet welds process were monitored and recorded by ZPMC and ABF QC inspector. Based on Caltrans QA Inspector observations, no discrepancies were noted.

Caltrans QA inspector observed four ZPMC workers and one welder performed fit up and SMAW tack weld process on the divide plate of counter weight component #54. A numerous temporary tack welds have been welded attach to the divide plate after adjusted and secured by hand jack. Based on Caltrans QA observation, no discrepancies were noted.

Floor beam type 1:- Caltrans QA inspector observed two ZPMC welders performed FCAW fillet weld process on stiffeners for type-1 of floor beam #FB-3055-001 AND #FB-6501-00. The fillet weld size is 6mm and 8mm with single pass and multiple pass. The FCAW fillet welds process were monitored and recorded by ZPMC and ABF QC inspector. Based on Caltrans QA Inspector observations, no discrepancies were noted.

Floor beam type 2:- Caltrans QA Inspector observed two ZPMC grinders in process of grinding on fillet welds of type 2 floor beams. The floor beams ID were FB-3015-002, FB-3026-001, FB-3070-001 and FB-3072-00. QA observed a numerous fillet weld areas identified by ZPMC and ABF QC that will require additional work due to

weld profiles exceeding AWS code limitations. The grinding process were monitored and recorded by ZPMC and ABF QC inspector. Based on Caltrans QA Inspector observations, no discrepancies were

Tower strut: - Caltrans QA Inspector observed two welders performed SMAW noncritical weld repair process on tower strut. The tower struts ID were WD1-A305-53M-2 and WD1-A305-65M-3. All of FCAW noncritical repair weld located at web to flange of tower strut which have been rejected by ZPMC UT testing. The FCAW repair process was monitored and recorded by ZPMC and ABF QC inspector. Based on Caltrans QA inspector observations, no discrepancies were noted.
